FACILITY COMPLIANCE INSPECTION REPORT

Division of Waste Management Solid Waste Section

Date of Site Inspection: 10/11/2012

Avery Co. C&D Landfill
2175 Brushy Creek Rd. (SR-1011)
Spruce Pine, N.C.

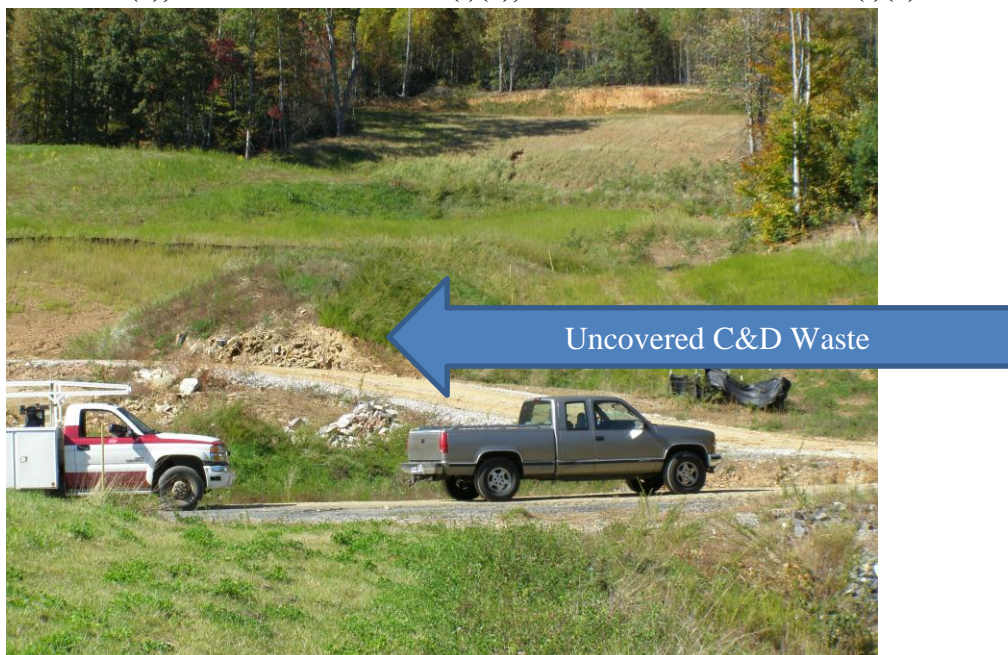
On October 11, 2012, construction and demolition waste was observed exposed and uncovered in two locations in the Construction and Demolition Debris Landfill. The first area was located along the access road to the active cell. The access road was constructed over an inactive cell in Phase 2. The area of exposed and uncovered waste in this location measured approximately 5 feet high by 10 feet wide. The second area of exposed and uncovered waste was located at the edge of the active cell near the working face and the toe of the slope of the inactive cells in Phases 1 and 3. The exposed and uncovered waste in this location measured approximately 6 feet high by 20 feet wide. Facility staff acknowledged that these areas were uncovered for an unspecified period of time that exceeded one week. The first area and a portion of the second area of exposed and uncovered waste was located in areas which would not have had additional wastes placed on them for three months or more and final termination of disposal operations had not occurred, and, the waste was not stabilized with vegetative ground cover or other stabilizing material. **This constitutes violations of 15A NCAC 13B .0203(d) by failing to abide with General Permit Condition Number 5 and General Permit Condition Number 6, 15A NCAC 13B .0542(a) by failing to maintain and operate the facility in accordance with the operation plan prepared in accordance with this Rule, and 15A NCAC 13B .0542(f)(1) and 15A NCAC 13B .0542(f)(2) by failing to cover and stabilize waste in accordance with these Rules. To achieve compliance, all waste must be covered and stabilized in accordance with 15A NCAC 13B .0203(d), 15A NCAC 13B .0542(a), 15A NCAC 13B .0542(f)(1), and 15A NCAC 13B .0542(f)(2).**

Digital Photograph taken by Deb Aja on 10/11/2012 of the first area of exposed and uncovered waste described above.

Public health and the environment can be compromised by failure to comply with these rules. Cover helps to prevent the interaction between the waste and the air, reducing odors, fire potential, and infiltration of precipitation and subsequent generation of leachate. Landfill fires can produce noxious atmospheric contaminants to the surrounding area.

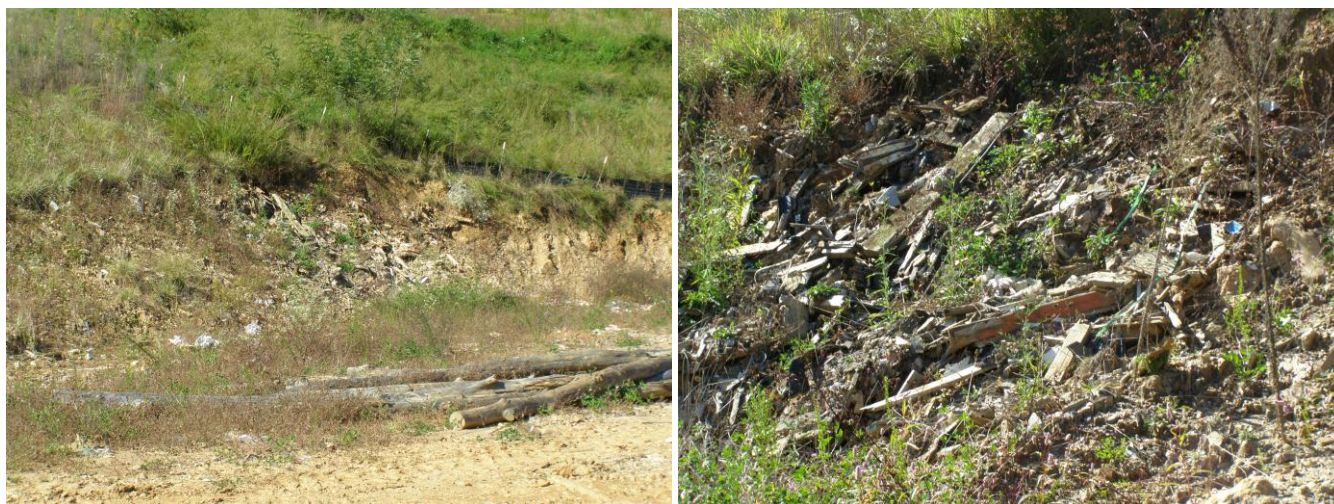
Digital Photographs taken by Deb Aja on 10/11/2012 of the second area of exposed and uncovered waste described above.

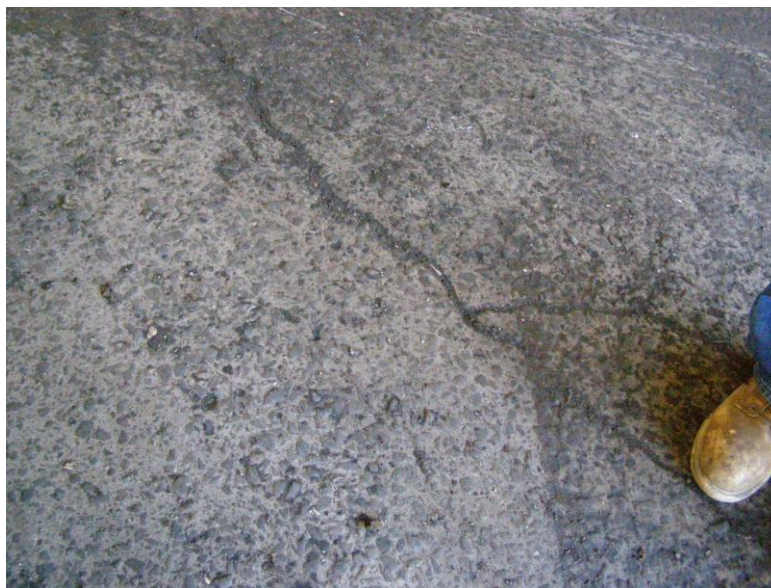
3. The tipping floor had been cleaned. Cracks were visible throughout the tipping floor surface and there appeared to be extensive wear over the entire surface. There was no movement of broken concrete observed in the surface layer. However, leachate could become trapped in the cracks at the surface and potentially reach the base layers. Should the tipping floor base layer be compromised below the cracked surface it would be possible for leachate to be released underneath the building and outside the leachate collection system. **Any release of leachate outside of the collection system would be a violation of the Solid Waste Management Rules and could require corrective actions. The facility should schedule making repairs to the floor as quickly as possible to remain in compliance and to avoid potential expensive remediation.**

Digital Photograph taken by Deb Aja on 10/11/2012 of the transfer facility tipping floor.

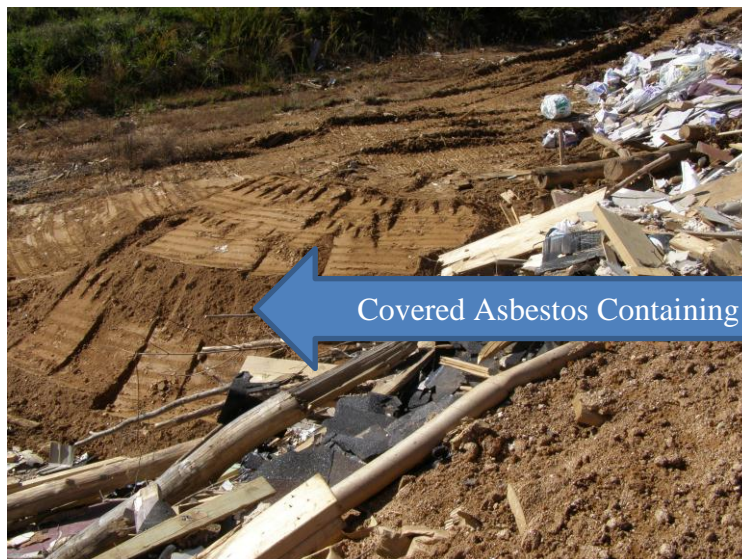
Covered Asbestos Containing Waste

23. Asbestos containing waste was accepted the morning of the inspection [3 yards]. The facility has devised an effective method of documenting the location of asbestos containing wastes based on a survey grid. The waste was placed and covered as required by Rule and in the Operations Manual [Special Waste Management, 2.6.4].

Digital Photograph taken by Deb Aja on 10/11/2012 of the working face and asbestos disposal.

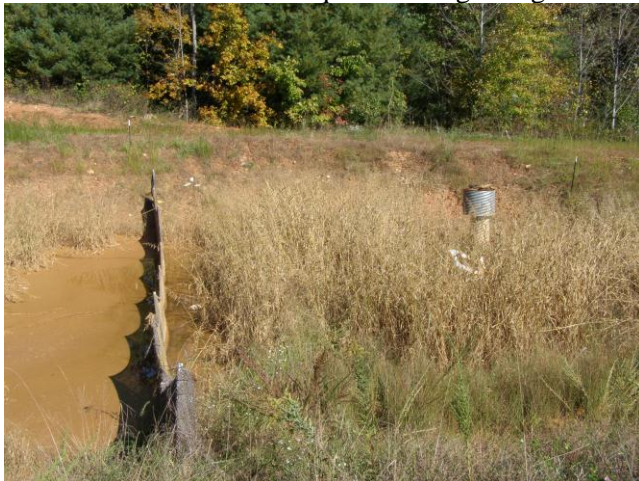
29. The storm water control devices (sediment ponds, skimmers, storm water control ditches, etc.) were observed. The Operations Manual [Environmental Management, 3.2.2] requires that the on-site basin be inspected regularly for sediment build-up or erosion damage. **The basin should be cleaned out when sediment fills the lower half of the basin.** It was stated that the skimmer was operational. The basin below the closed portion of Phase 2 must also be cleaned out if sediment has filled the lower half of the basin. Please contact Kristin Hicklin, Assistant Regional Engineer, Land Quality Section at 828-296-4500 if you would like to discuss or have additional questions regarding erosion and sedimentation controls at the site.

View of sediment Basin 3.

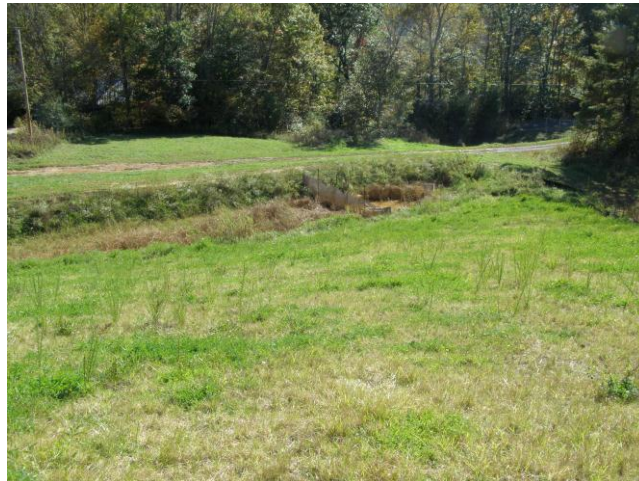
View of Sediment Basin 4.
